# Manhole Inspection Summary

Manhole # S31K\_\_029MH

Insp Date: **11/23/08 11:59 AM**

**Location** Address: **643 Warner St**

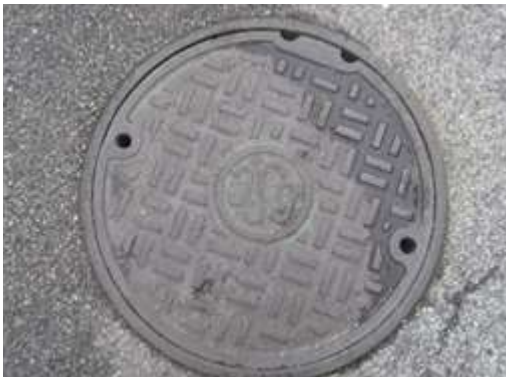
Miscellaneous

MH cover

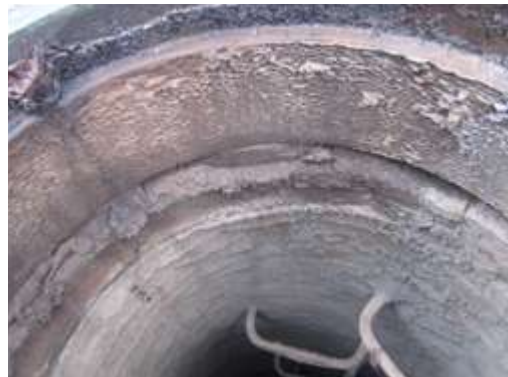
Defect 2

Condition: ☐ Sound ☐ Cracked ☒ **Leaks**

frame infiltration at cover

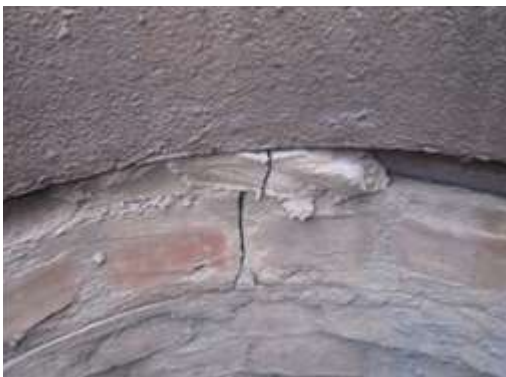
Defect 1

Condition: ☐ Sound ☒ **Cracked** ☐ Root Intrusion ☐ Loose Brick ☒ **Deteriorated**

chimney cracked mortar and gap at frame joint

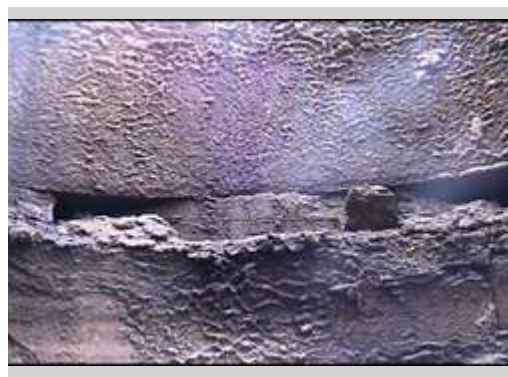
Defect 4

Infiltration: ☐ None ☒ **Joint** ☐ Cracks ☒ **Mortar** ☐ Roots ☒ **Wall**

chimney deteriorated with infiltration from joint, mortar, & wall

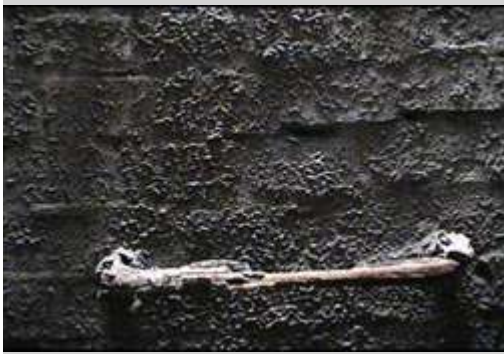
### Defect 3

Count: **6** Missing: **0** ☒ **Corroded**

steps corroded

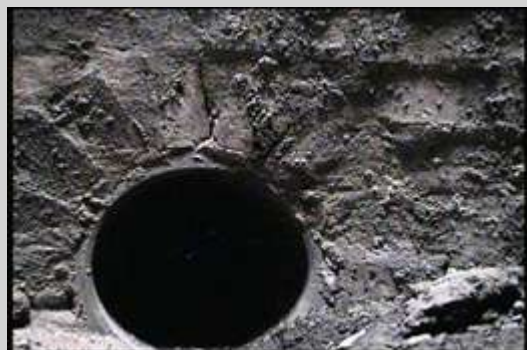
12 O'Clock Outflow

8 in. Circular Gravity Sewer  
Pipe Out @ 12 O'Clock

Infiltration: **None** Pipe Seal Cond: **Sound**
